# Evaluation of Support and Ground Response as Longwall Face Advances into and Widens Pre-Driven Recovery Room

**Thomas M. Barczak**, Senior Research Engineer  
**Stephen C. Tadolini**, Chief, Rock Safety Engineering Branch  
NIOSH-Pittsburgh Research Laboratory  
Pittsburgh, PA

## ABSTRACT

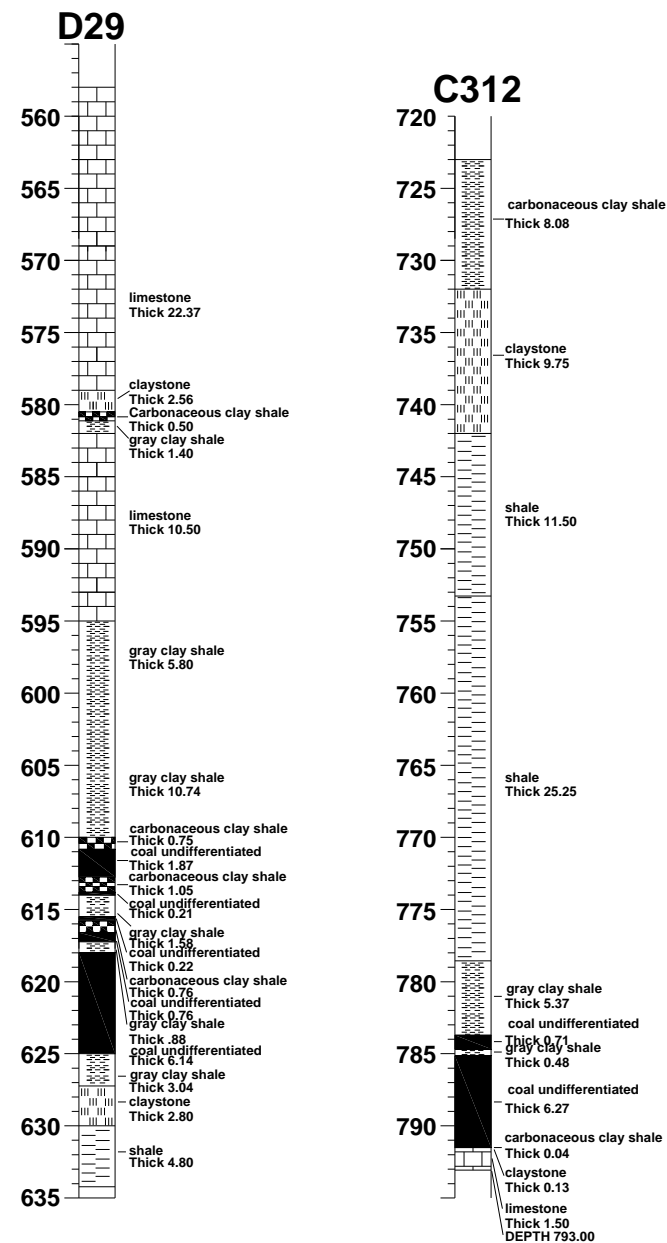
Figure 1. Geological columns in the longwall recovery area.

The B4 longwall panel was 1,450 ft wide. The depth of cover averaged 600 ft. Figure 1 shows the roof lithology from two coreholes near the B4 recovery area. The immediate roof consists of clay shale, silty shale and rider coal, which is common to the Pittsburgh seam providing a relatively weak immediate roof structure. The area is overlain by 10 and 22-ft thick limestone members and 11 and 25-ft thick shale layers as shown in figure 1.

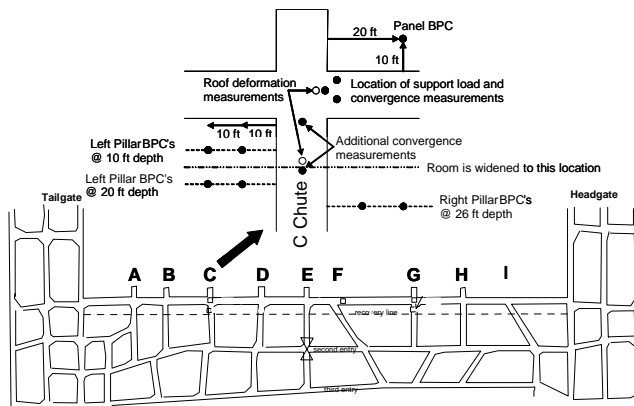
Figure 4. Diagram showing instrumentation in the longwall recovery room.

- Borehole Pressure Cells were used to measure panel and outby pillar stress development in the C chute area. Figure 4 depicts the location of the cells. One cell was installed in the panel 10-ft from the recovery room to measure yielding of the panel fender as the longwall face approached, two cells were installed in the outby pillars at a depth of 10-ft and two other cells 20-ft from the from the outby edge of the recovery room to measure load transfer from the panel to the outby pillars. Two more cells were installed 26-ft from the outby edge of the recovery room in the adjacent pillar of the C chute location, again to measure load transfer from the longwall panel as the fender yielded.

The shield leg pressures provide further insight into the loading mechanisms associated with the panel fender yielding. The panel stress measurements are located adjacent to the C Chute location and shield number 175 (see figure 4), which is about 1,000 ft from the headgate on

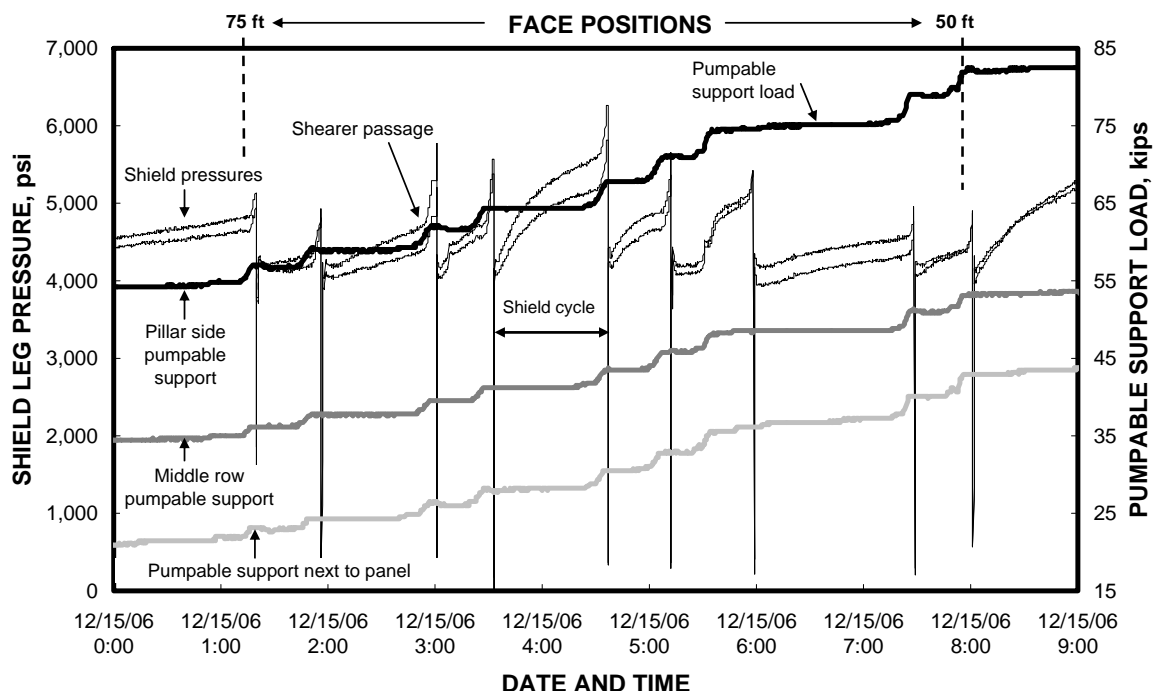
Figure 5. Correlation between pumpable support load and shield cycle showing load increase during shearer passage.

the main roof activity. Figure 5 shows an example for shield number 175 (adjacent to Chute C in the recovery room) as the face advanced from a location 75 away to 50 ft away the recovery room. As the face advanced closer than the 50 ft location, the pumpable supports began to increase in loading during the full shield cycle, but the majority of the load increase continued to be consistent with the shearer passage and a step-type function in the load development continued.

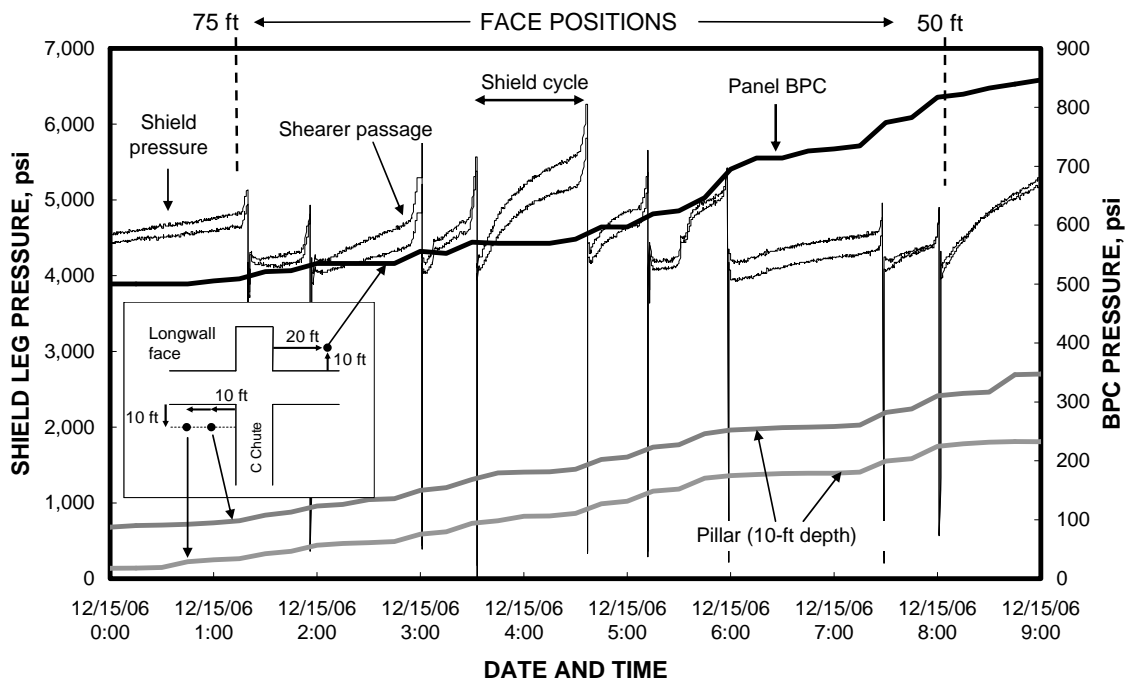
Figure 6. Correlation between borehole pressure cells and shield cycles.

The Borehole Pressure Cells (BPCs) monitoring the panel and pillar stress followed a similar pattern, although not as distinct as the support loads (see figure 6). Part of this was due to the much

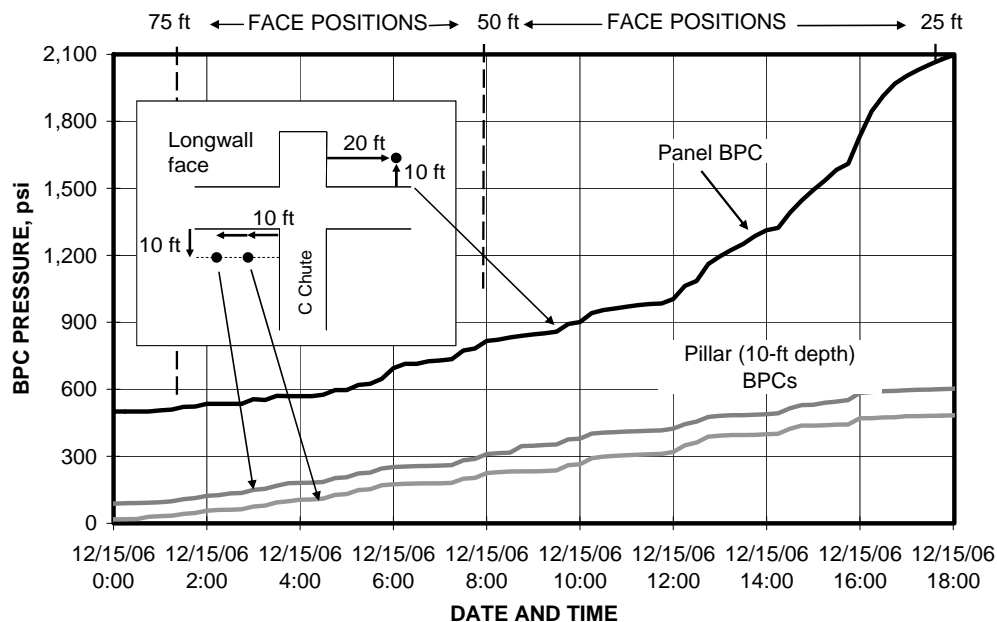
Figure 7. Stress on the panel BPC began to increase at a faster rate than the pillar BPC as the face advanced closer to the recovery room.

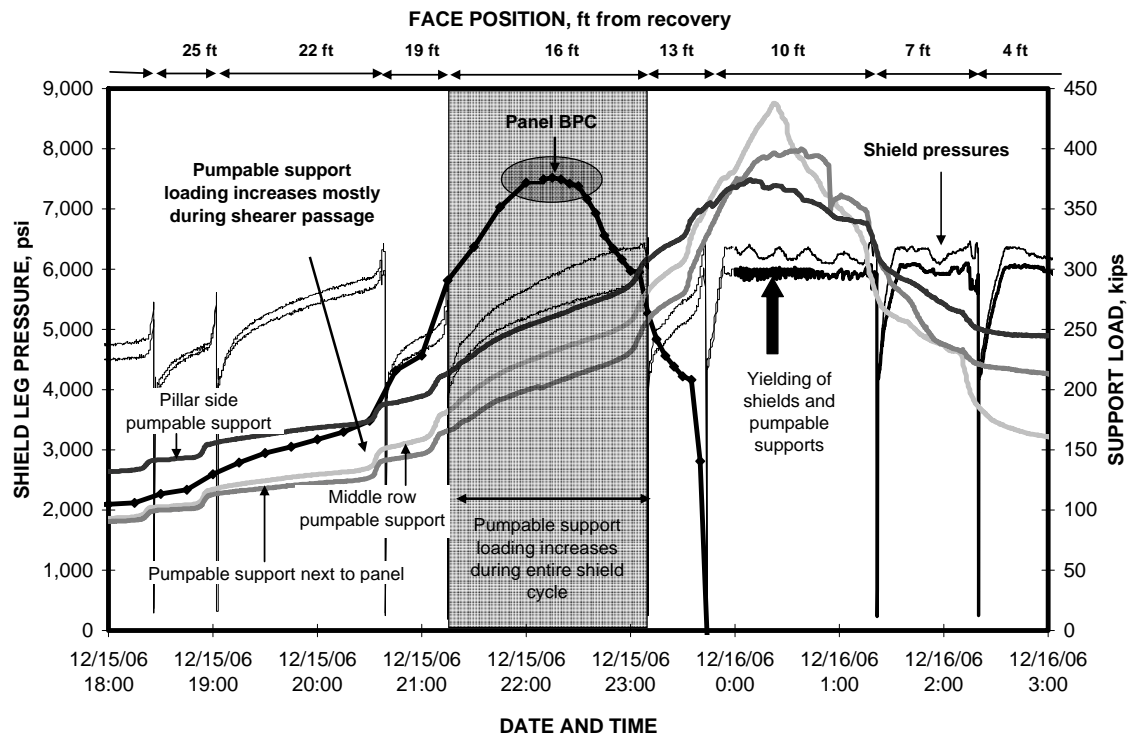
Figure 8. When the longwall face was approximately 16 ft inby the recovery room, the pumpable support loading increased during the full shield cycle.

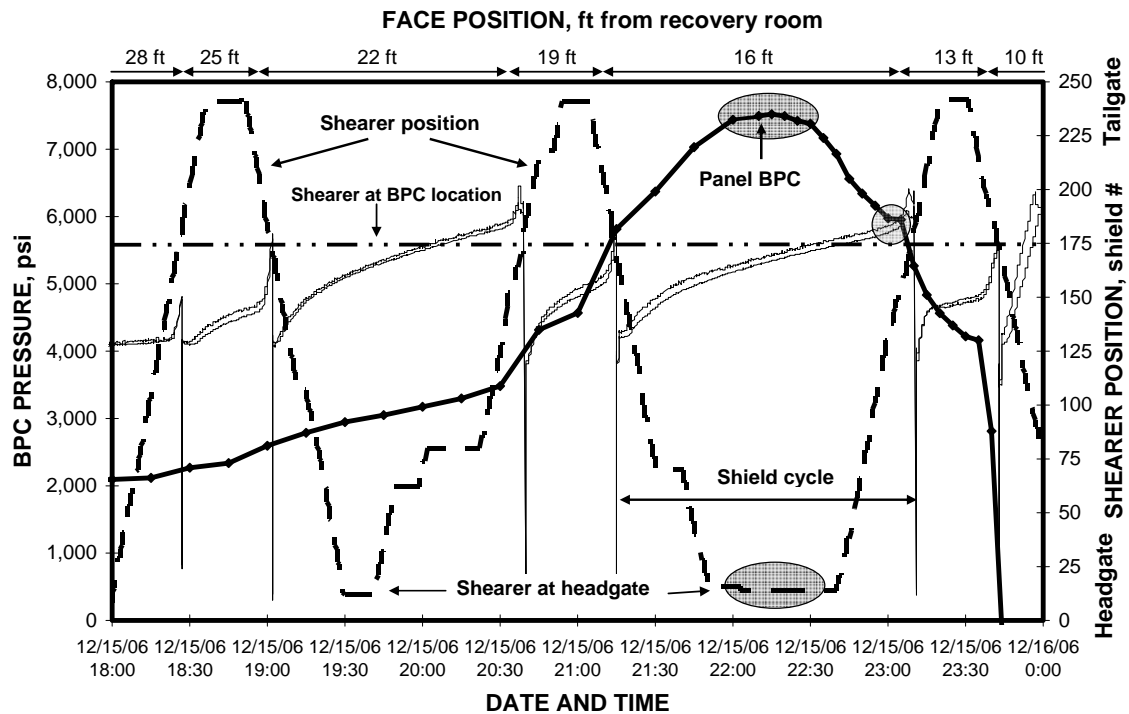
Figure 9. Yielding of panel BPC occurred when the longwall shearer was approximately 1,000 ft away from the cell location.

this 1,450 ft-long face. For bidirectional cutting, the shield cycles are likely to alternate between short and long cycles since the support is located away from the center of the panel where the shield cycle time differential would be minimized. As shown in figure 9, the panel fender yielded during a long cycle (114-minute duration) as the shearer had to move to the headgate and back to complete the loading cycle. It was somewhat surprising to observe that the peak stress occurred not when the shearer passed by this location, but when the shearer was over 1,000 ft away at the headgate, particularly given the close proximity of the longwall face to the stress cell (approximately 6 ft away). This could be the result of the time dependent properties of the coal, in which the highly stressed coal will continue to deform (strain) even under static load conditions. The unloading rate is also nearly the same as the loading rate during this shield cycle. The detail of the loading is magnificent as exemplified by the temporary stop in load shedding when the shearer passes back in front of the pressure cell (see figure 9).

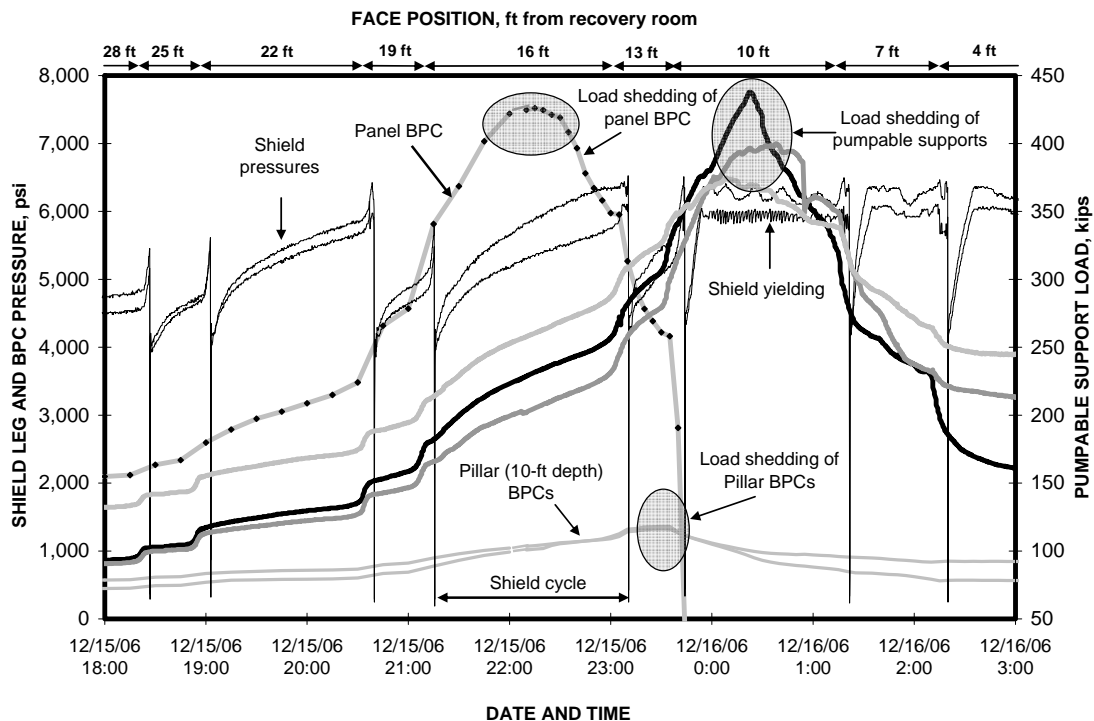
Figure 10. Evaluation of load shedding associated with pumpable supports and BPCs measuring panel and pillar stress.

These two cells peak and then gradually shed load during the shearer passage on the shield cycle following the peak loading of the panel cell (figure 10). Since the stress levels on the pillar cells were only 25% of the level that caused yielding of the panel cell, it is unlikely that the coal pillar at the cell location was actually yielding due to loading

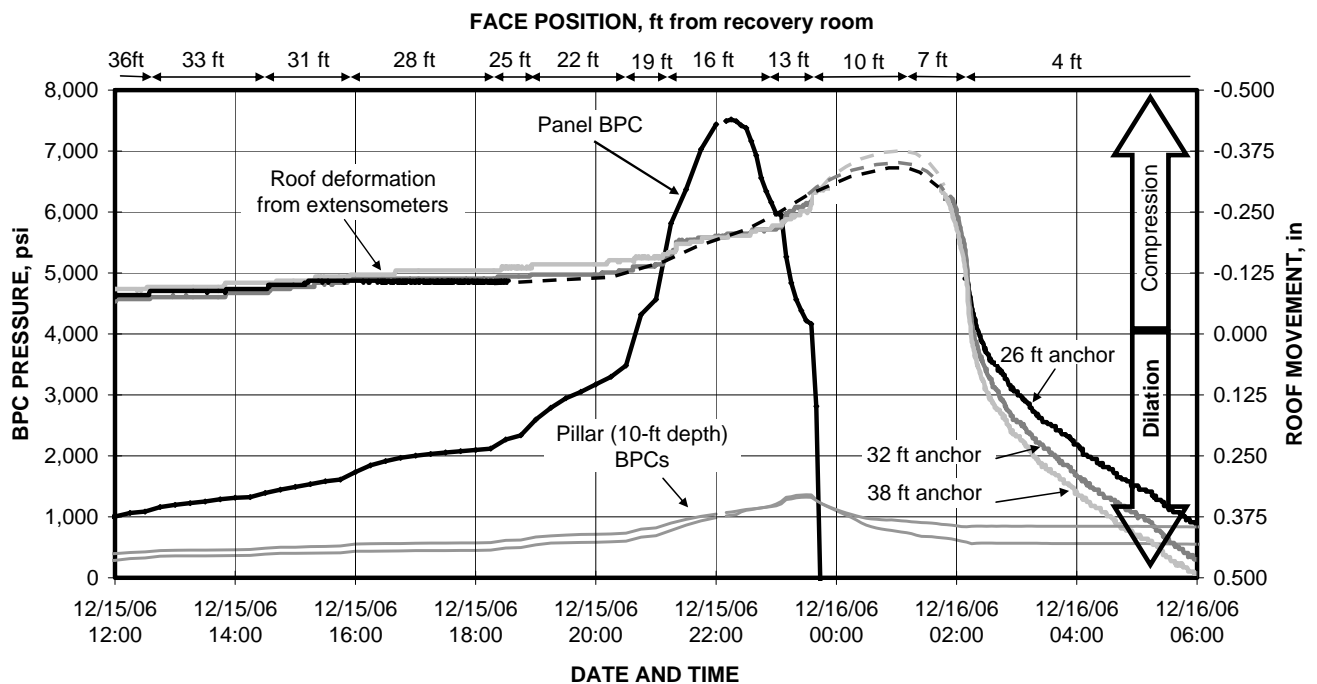
Figure 11. Roof initially is compressed during yielding of panel fender and then begins to deform downward into the recovery room.

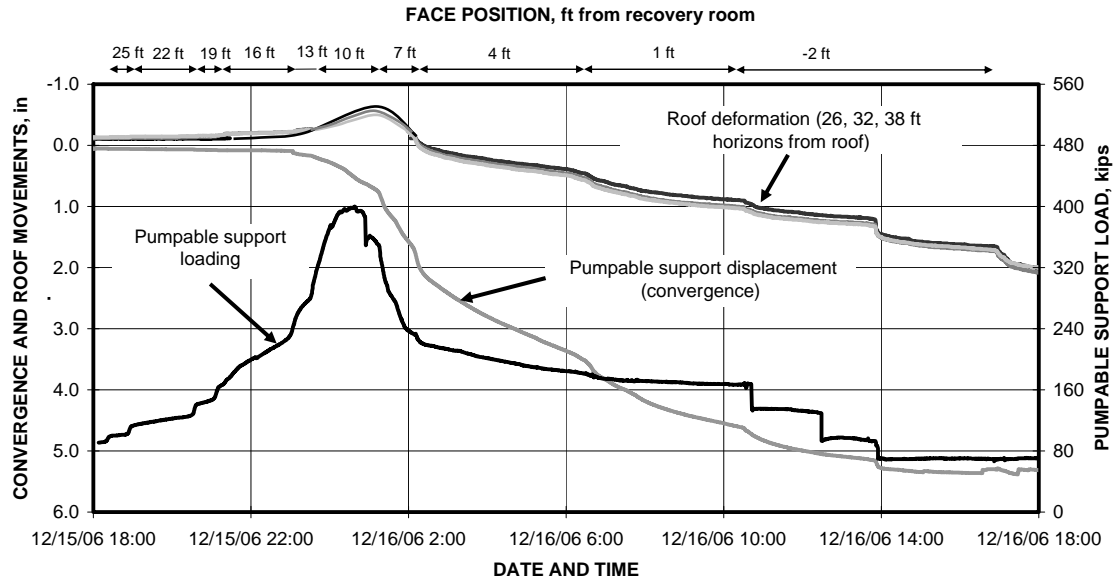
Figure 12. Roof deformations and convergence profile during pumpable support loading and failure.

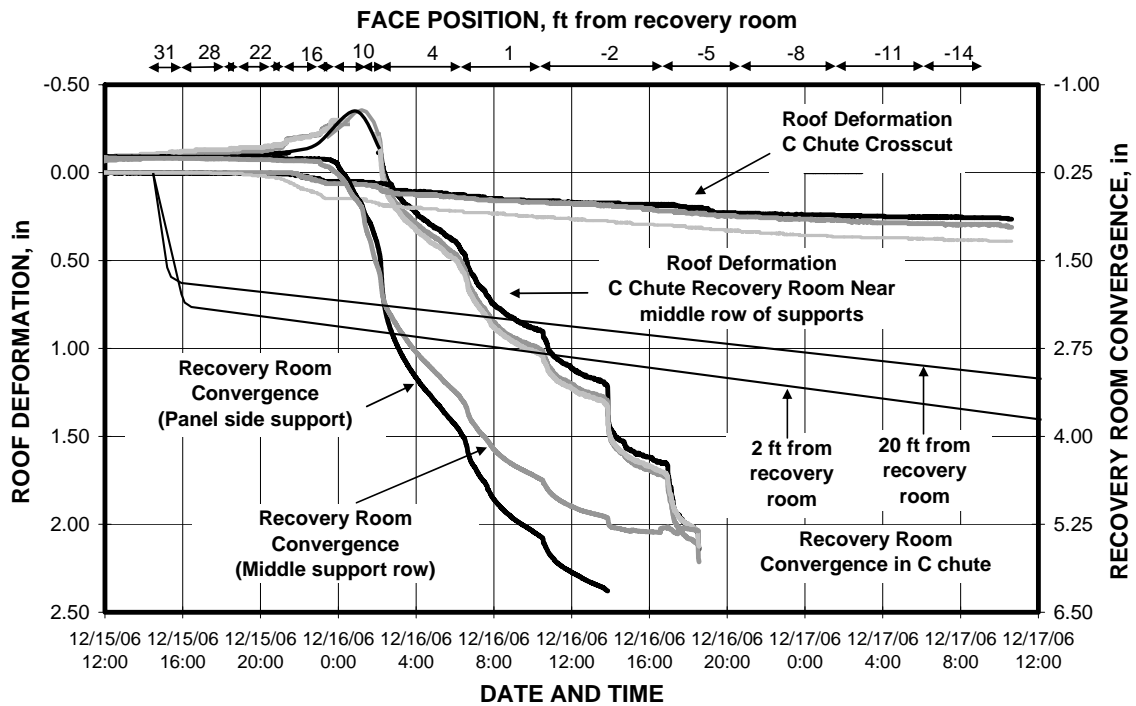
Figure 13. Convergence and roof deformation profiles in C Chute area of recovery room.

locations from the edge of the recovery room, remained fairly constant during this process. The roof continued to deform slightly in the chute as measured by a three-point extensometer in the center of the entry located 16 ft from the outby edge of the pre-driven recovery room, but the deformations were nearly an order of magnitude less than that seen in the recovery room. An additional 1 in of closure occurred for a distance of about 20 ft in the C chute crosscut as measured by electronic closure meters measuring roof-to-floor displacement (see figure 13).

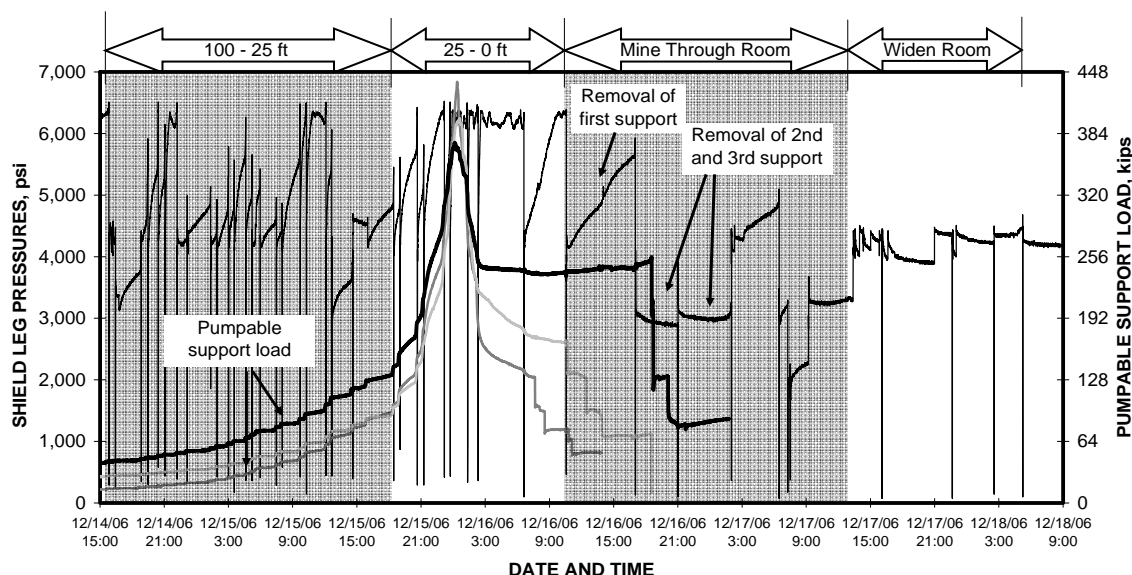
Figure 14. Shield loading decreased as the pumpable supports were extracted from the longwall recovery room.

supports can be critical to the stability of the recovery room. At the C chute location, the shield loading decreased as the supports were extracted and the face advanced toward the pillar line (see figure 14). As the first row of supports was being extracted, the shield loading remained high but below the yield rating. As the second row of pumpable supports was being extracted, the shield loading did not change much after being set and this condition remained throughout the advancement through the pre-driven recovery room. The pillar stress, as measured by the cells at both the 10-ft and 20-ft

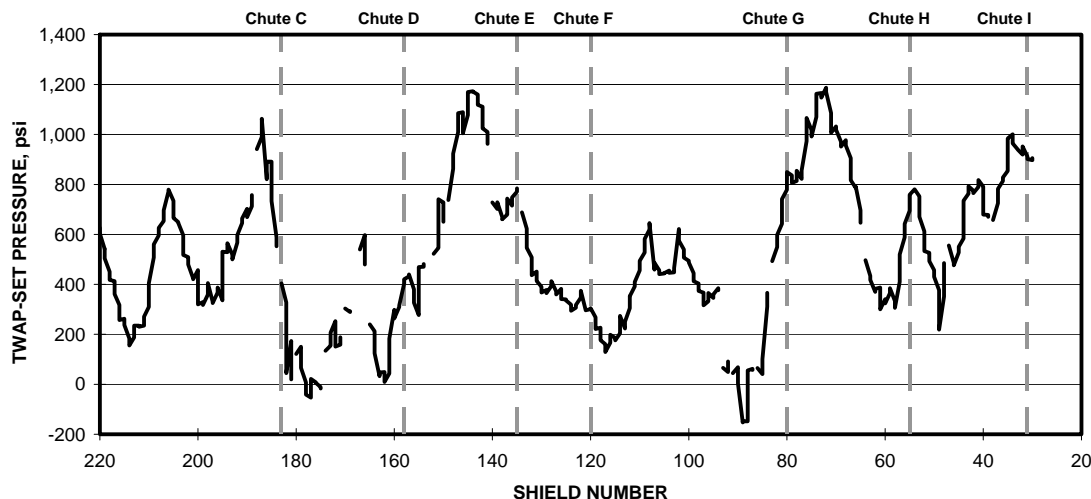
Figure 15. Shield loading was low but did vary across the face during and after the extraction of the pumpable supports.

The time-weighted average shield pressure varied across the longwall face during the phase of mining in which the supports were cut out and the face was advanced through the pre-driven recovery room. This is shown in figure 15, which plots the change in shield loading (difference between the time-weighted average pressure and the setting pressure), as the last row of supports were being extracted and the face advanced to the pillar line. The shield loading at some locations was considerably higher than that observed at the three instrumentation sites. One example is shown in figure 16, where shield number 185 yielded on all cycles during the extraction of the pumpable supports and advancement through the pre-driven recovery room compared to shield 175 which had little change in loading during and following the extraction of the last row of supports. There was no obvious visual physical difference in the recovery room condition. Without

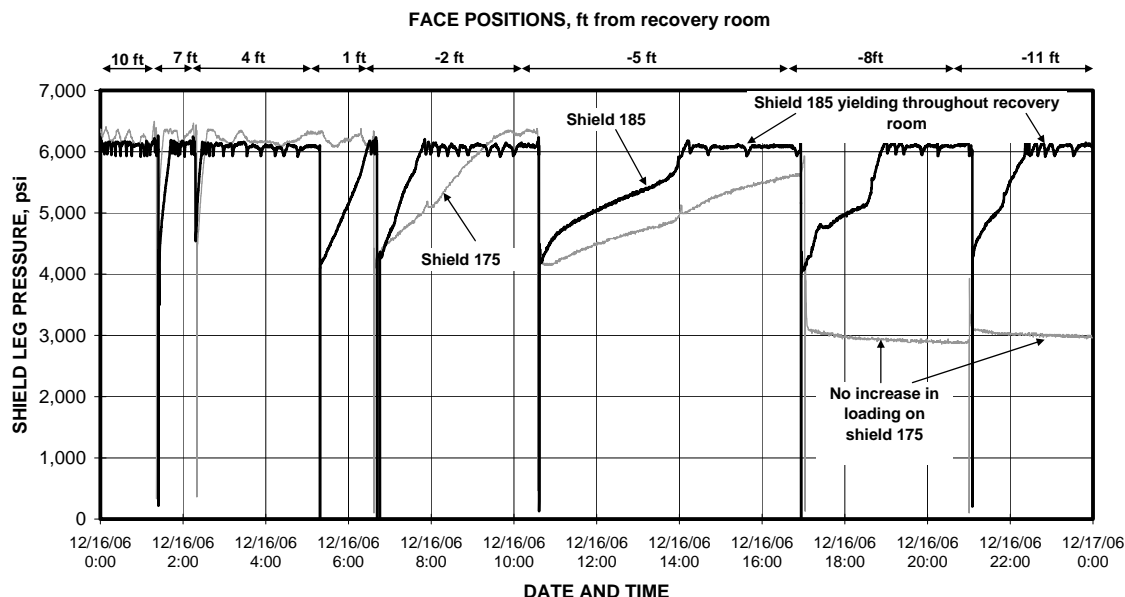
Figure 16. Comparison of two shields, one with high shield loading and one with low shield loading, during and after pumpable support removal.

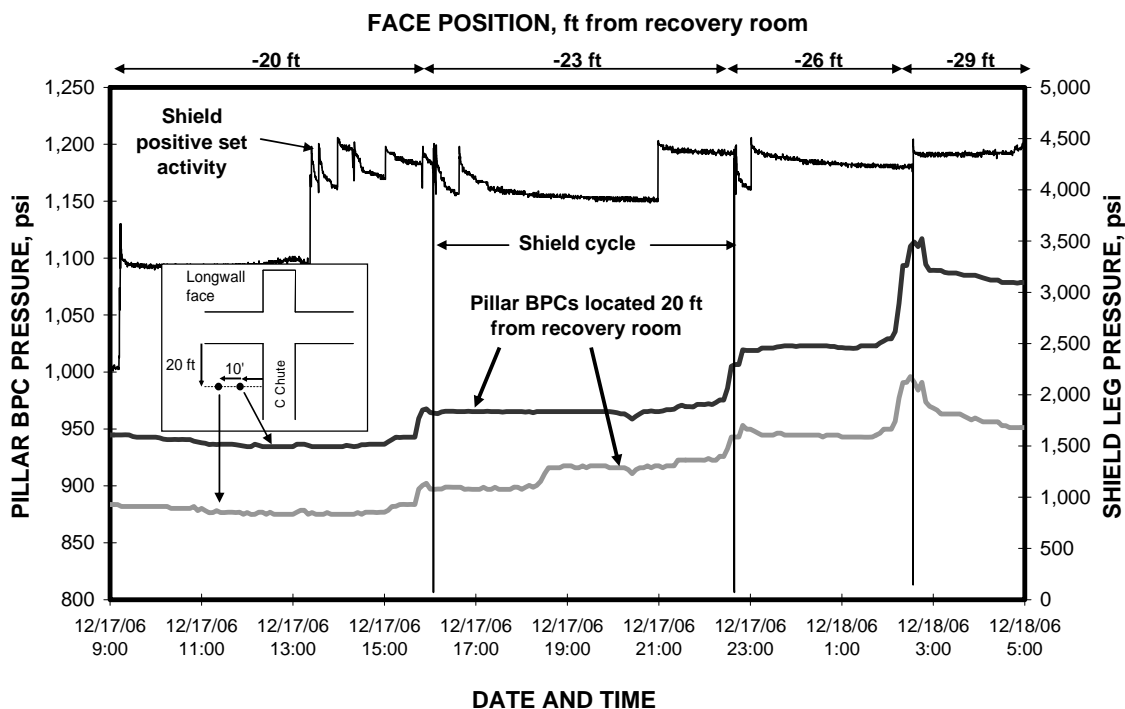
Figure 17. Outby pillar pressure cells show effects of shearer advance as pillar is extracted to widen room.

The BPCs located in the pillar at depths of 10 ft and 20 ft from the recovery room again document the impact of the shearer passage on the loading mechanics. As the face cuts to the 10 ft

location, the measured pressure change in the cells located there spiked to 2,852 psi and then shed load rapidly as the cell and/or contact condition is damaged from the shearer activity. As seen in figure 17, the pillar stress measured at the 20 ft locations increased with each shearer passage and remained fairly constant once the shearer cut was made until the next mining cycle. Overall, the load increments were much smaller than that observed with the panel fender yielding. These pillars do not yield. The convergence measured from the electronic convergence meters also continued to increase during the pillar extraction at about the same rate as when the pre-driven room was mined through (see figure 13). As the extraction approached the location of the convergence rods, the convergence rate increased significantly as expected.
